Human Factors Analysis of Predator B Crash

MIT Humans and Automation Lab

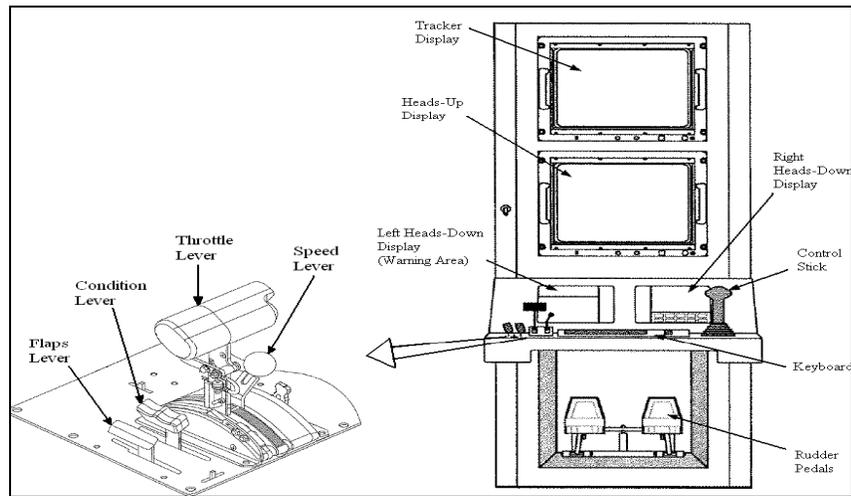
Figure 3: PPO-1 Setup with Condition Lever [3]

The condition lever shown in Figure 3 played a significant role in this mishap. In pilot mode, the condition lever controls the engine. The condition lever in the forward position allows fuel flow to the engine, the middle position closes or stops fuel flow (shutting the engine down), and the aft position feathers the propeller blades to reduce drag. In payload operator mode, the condition lever changes the camera's iris setting. Moving the lever forward opens the iris, placing it in the middle position locks the iris in its current setting, and moving it back narrows the iris. The condition lever functions are summarized in Table 1. If control is transferred from one console to the other, the checklist dictates that the condition lever position on the payload

This failure to follow the checklist became one of the major factors leading to the crash. When flight control was switched from PPO-1 to PPO-2, the two condition levers were not matched. The mishap pilot was unaware of the mismatched control situation which led to mode confusion [4]. Mode confusion occurs when the state of a system is overlooked, and a technical system behaves differently from the user's expectation [5]. Initially, the pilot console lever was set to allow fuel flow (forward position) and the payload operator console lever was set to lock the iris (center position) [3]. After the transfer, the iris setting became the new engine setting,

causing the engine to shut down. If the pilot had followed the checklist, this error may have been noticed or prevented.

The first is the need to address basic human factors considerations when designing a UAS. The most immediate cause can be traced to the mode confusion seen in the condition lever of the operating station, which was amplified by a lack of training and poor oversight by GA-ASI and CBP. These shortcomings were exacerbated by the latent error of a poorly designed backup system. Mode confusion is a well-known and well-researched phenomenon in manned aviation. This could have been prevented with additional automation that would provide a warning and lockout if a transfer is attempted when the controls are not matched. While some would advocate for more training to address this problem, humans are imperfect systems, and it is important to design for an operator that may make mistakes [8].
